Enhancing Safety-Critical Assembly Processes through Electrical Testing: Advanced Manufacturing Solutions for Wire-Harness Assembly in Treadmill Components

Dhrudipsinh Dabhi

Technical Program Manager

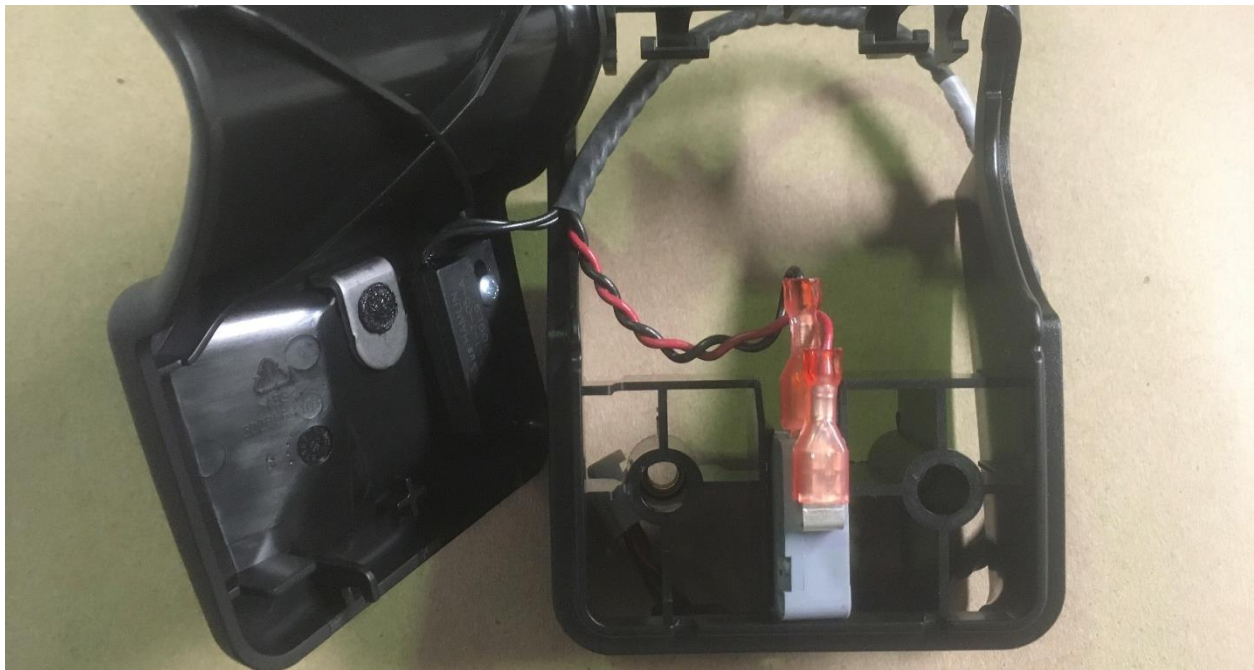
When this safety issue was first brought to my attention, my immediate priority was to determine the extent of the problem and why it occurred in the first place. The treadmill component assembly process included a wire-harness base that connected to a stop-button mechanism—a critical safety feature. Upon deeper investigation, I discovered that the root of the problem was directly tied to the design of the plastic socket that housed the wire-harness base. The socket was designed without any keying or guiding features that would force the wire-harness base to be installed in only one orientation. This oversight created a situation where the base could be seated both correctly and incorrectly, with no visual or tactile indication to the assembler as to which way was correct.

Figure 2: "Close-Up of Misaligned Wire-Harness Base"

The root of this issue lay in two critical aspects: the design of the part itself and the manual assembly process. The plastic socket design had too much room for error, allowing the harness to be seated upside down without immediate detection. In a fast-paced manufacturing environment where human assembly plays a role, it is crucial that parts are designed to be as foolproof as possible to minimize the risk of assembly errors. However, in this case, the design of the socket lacked the necessary restrictions to ensure correct orientation.

The first solution I proposed was an engineering change to the design of the plastic socket. The goal was to modify the socket in a way that would physically prevent the wire-harness base from being seated incorrectly. I worked with the design team to suggest the addition of keying features—small ridges or tabs within the socket that would only allow the base to fit in one orientation. With this design modification, if the operator attempted to install the wire-harness base upside down, it simply wouldn't fit, and the cover wouldn't sit flush. This would immediately alert the assembler to the error and prevent the part from being assembled incorrectly. Additionally, the design was adjusted so that if the base was incorrectly oriented, the stop-button wouldn't engage, and the assembler would hear no "clicking" sound, which was a key part of the assembly verification process. By introducing these design constraints, we aimed to eliminate any possibility of human error during manual assembly.

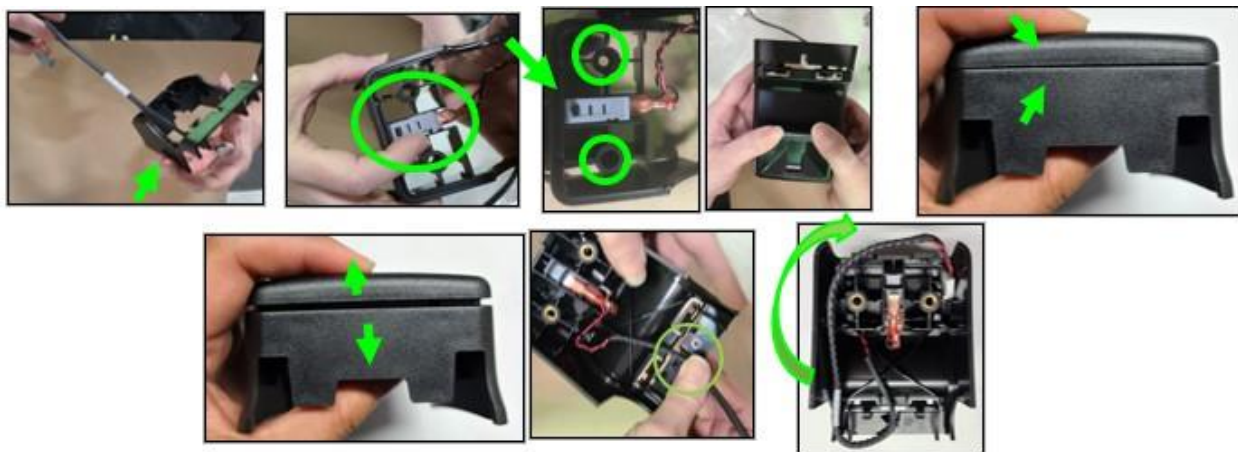
Figure 3: "Correctly Reassembled Wire-Harness Base"

- 2. Disassembly and Reinstallation:** After identifying the suspected lots, I personally took charge of disassembling the affected units, both at our facility and collaborating with customers at the customer's facility. In total, I reviewed and corrected several assemblies, ensuring that the wire-harness base was reinstalled in the correct orientation. At the customer's site, I worked alongside their team to inspect and fix the assemblies in three full boxes and the partial box, preventing any defective treadmills from being delivered to their final destinations.
