Climate - A Key Determinant to Design and Maintenance - An Appraisal of the National Theatre, Iganmu, Lagos

Asaju O A, Dare-Abel O A, Daramola S A

Department of Architecture,
Caleb University, Imota, Lagos State

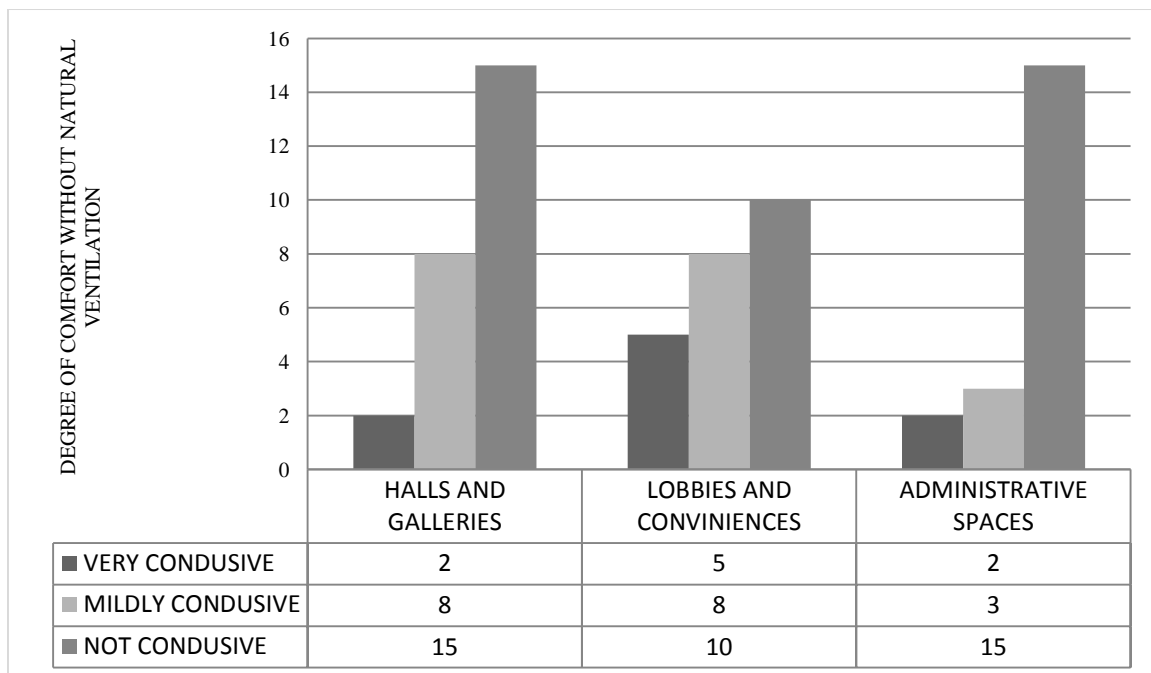
Figure 1 - User's View On Thermal Comfort of the Facility without Natural Ventilation
(Source: Author's Field Survey, 2019)

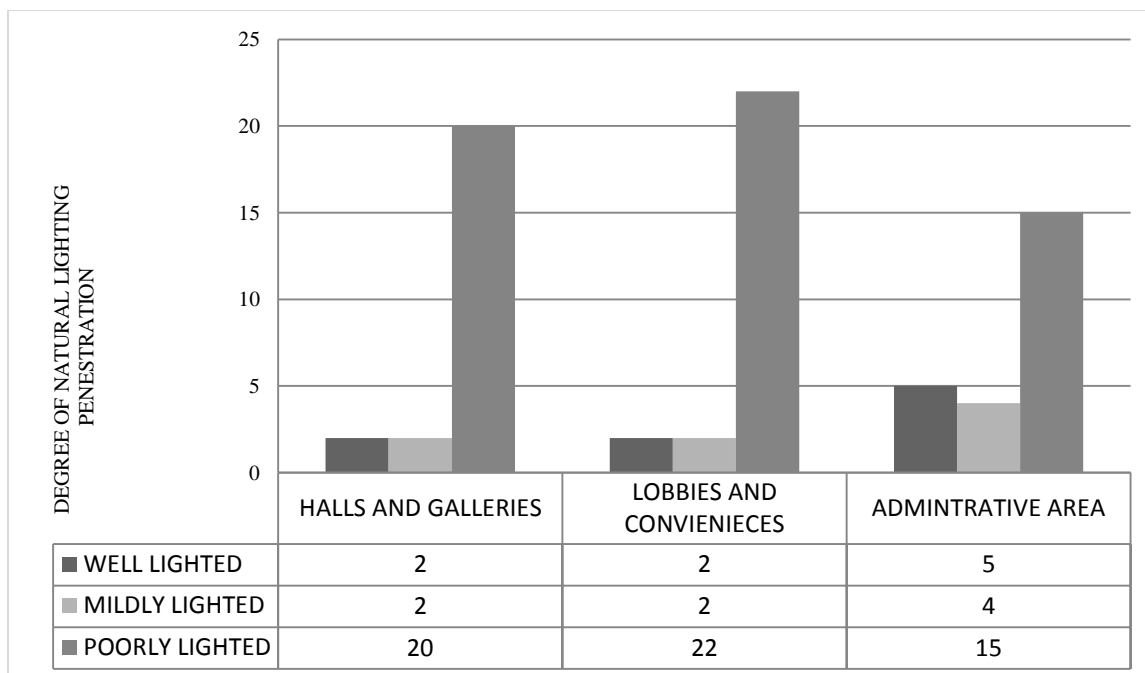
Figure 2 - User’s View of the Facility without Natural Lighting
(Source: Author’s Field Survey, 2019)

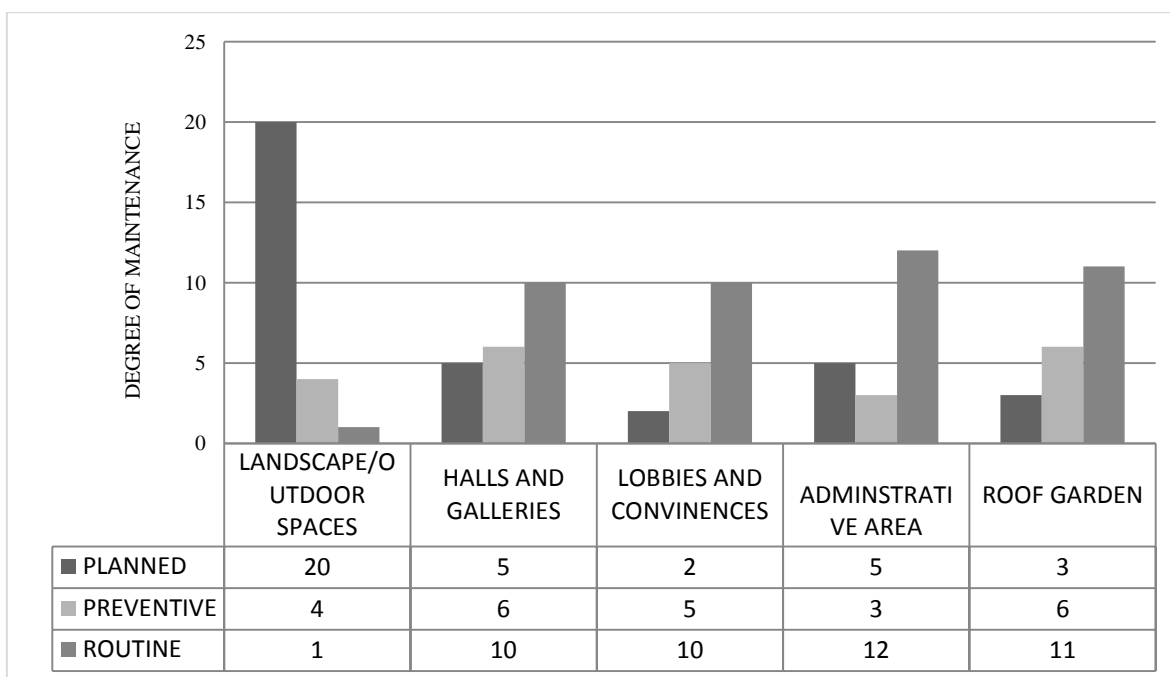
Figure 3 - User’s View on Maintenance of the Facility
(Source: Author’s Field Survey, 2019)

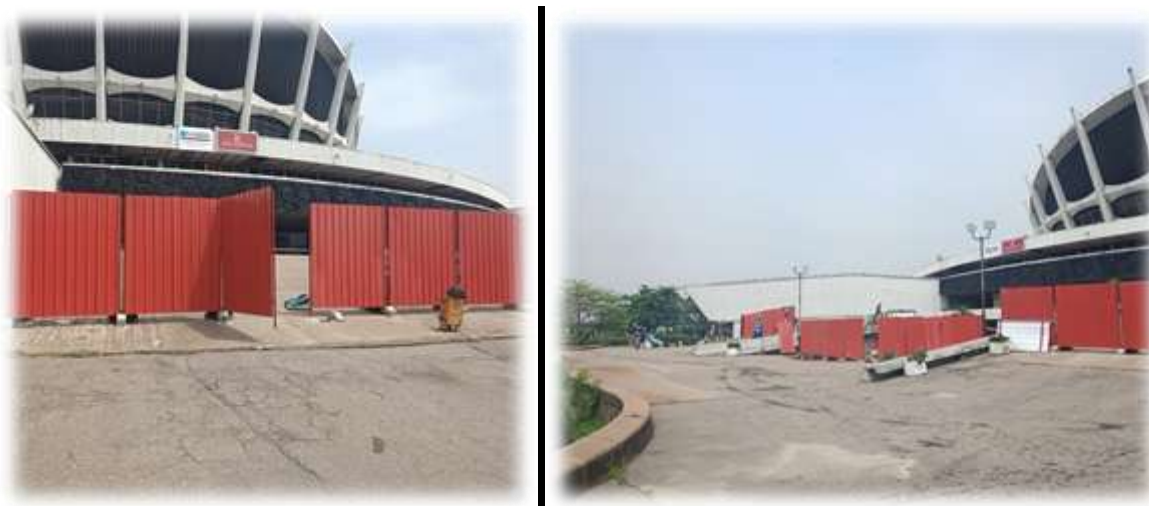
Figure 4 - Hoarded Structure for Rehabilitation
(Source: Author's Field Survey, 2021)

Presently, maintenance has commenced which is believed to be a major one as previous ones was to sections of the structure especially the roof garden which is full concrete and has being allowing seepage of water of the years. Though little has being done to stop it, it is still believed that more will be achieved after the ongoing maintenance must have being completed. It is believed that this maintenance will bring a total transformation to the building, but will it also reverse it to a climate friendly design? That we are
